The Pennsylvania Land Trust Association (PALTA) recently had its annual conference in Gettysburg. One of the sessions was entitled “Protecting the fields around the barns...and the barns in the fields”. By the fact that I am an inherent “do gooder” at heart, I currently serve as the president of both the Historic Barn and Farm Foundation (HBFF) and PALTA boards of directors, as well as being on the board of NBA. The idea is that land trusts and state agricultural preservation programs might be induced to preserve historic resources, especially barns, or at least address this issue, as part of their respective programs.

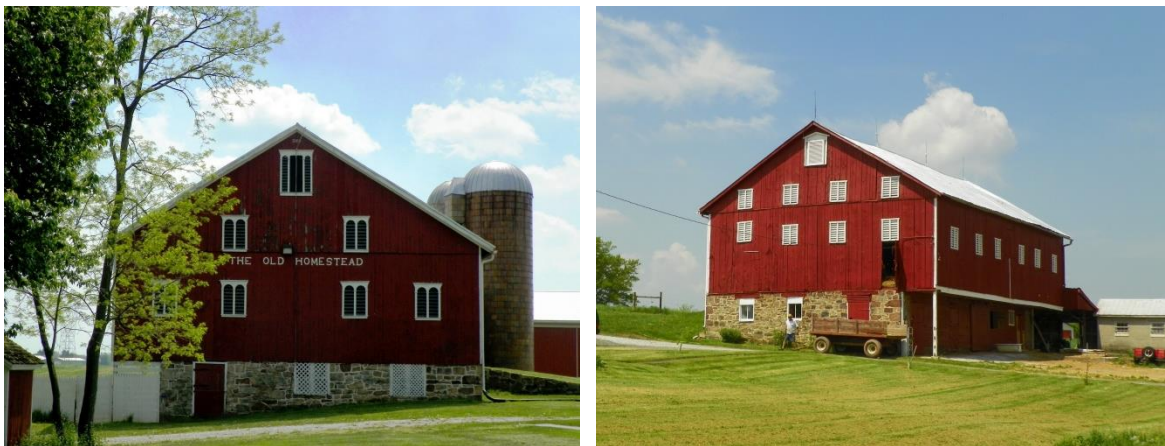
Both barns are Standard Pennsylvania barns that were noted in contemporary literature as “frame barns, stone stable high”. The barn shown above left has a date of 2008 at the peak of the gable.

The barn shown above right shows how these barns often had doors in the gable end to facilitate loading and unloading. Both barn owners came out and were proud to talk about their barns

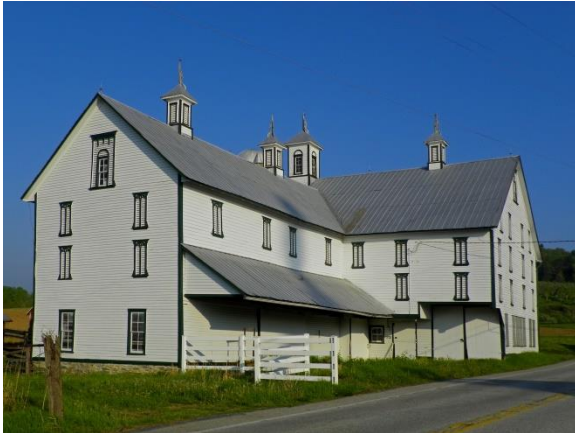
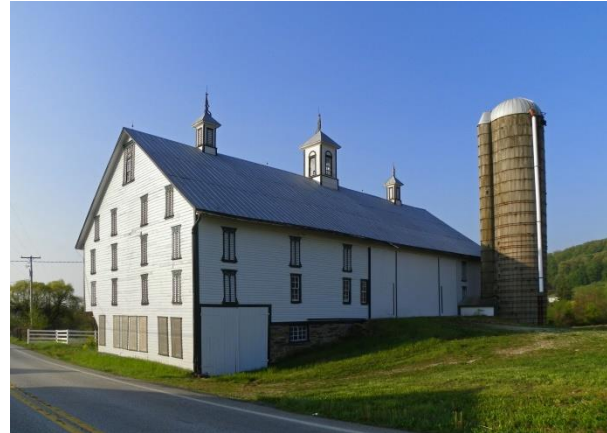
This three gable barn has a large central cupola and flanking smaller ones on the main barn and "L". You can also see the machine bay on the south and north elevations. This barn is located less than a mile from the round barn just off Route 33W.

One of the most obvious is the wonderful variety of cupolas and louvered openings found on the wooden superstructure of the barn. The variety of detail and ornamentation of these features is amazing.

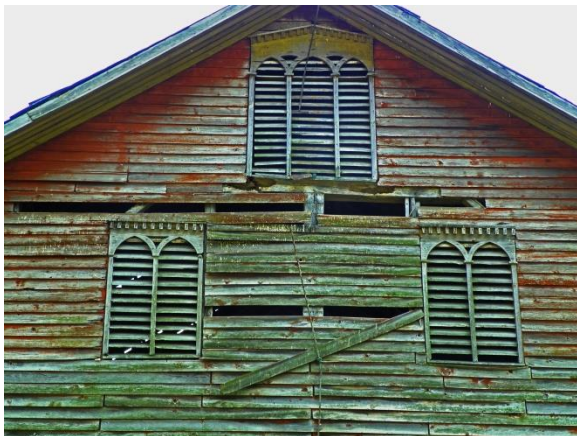
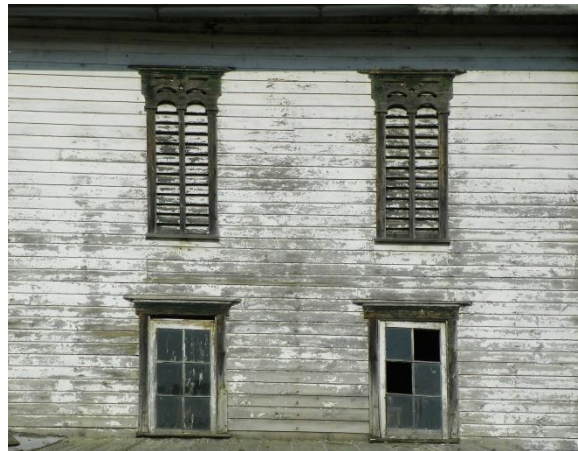
Examples of the variety of louvers found in the area.

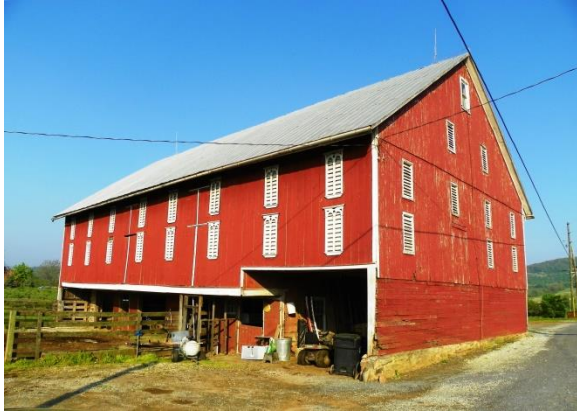
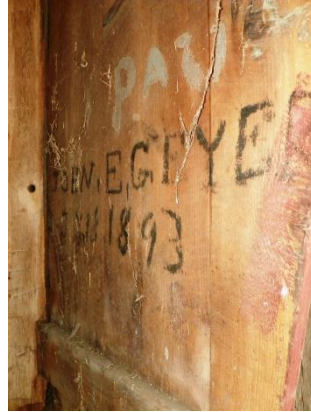
Note the large opening next to the forebay for machinery. There is a integral corncrib along the gable wall which has the date of 1893 painted on it.

A less obvious, but prevalent, feature of these barns is an integral wagon or machinery bay for the protection of wagons and other farm machinery. These bays are often is open on both the barnyard and rear elevations. While many terminate with the gable wall, a large number of a corn crib incorporated on the outside wall of these bays.

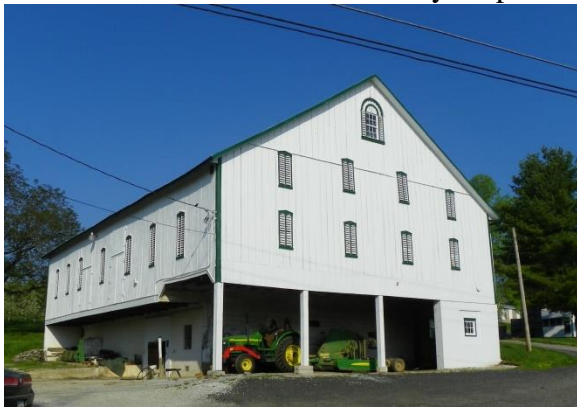
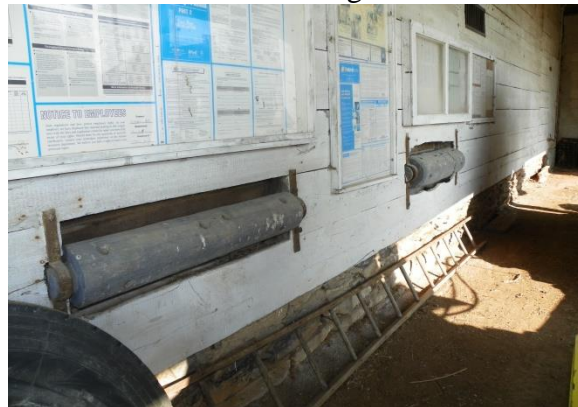
The owner of this barn (dated 1882 in the semicircle above the gable window) removed the exterior wall and integral corncrib. The windlasses (above right) are obscured by the farm equipment in the overall photo.

According to the owner of this barn, many of these barns have windlasses to raise a wagon bed from its chassis. There were hooks for pulleys on the beams above the wagon bay. In other instances windlasses were actually suspended between the beams forming the floor of the loft.

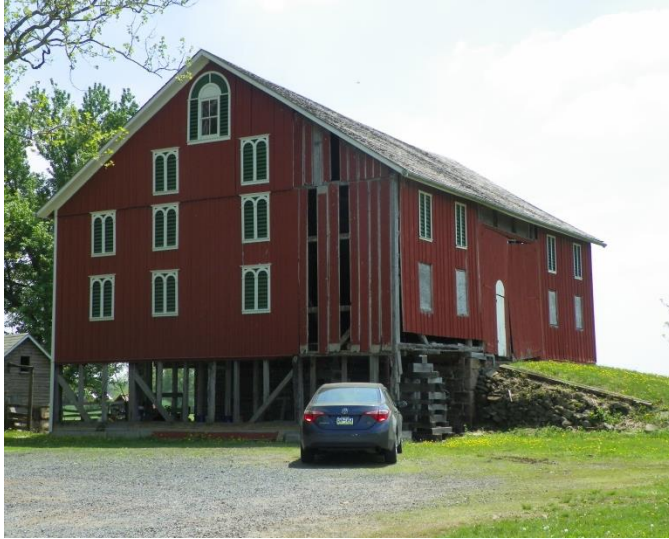
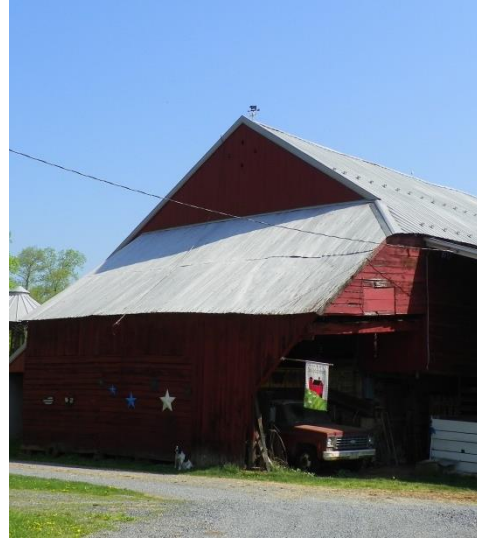
On the barn above left the wagon bay is being repaired. Note that there is a stone stable-high wall visible on what was the inside wall of the wagon bay. On the barn above right the wagon bay is not incorporated within the main barn, but in a shed wing. Note the spaced slats of the corncrib in the outside wall. This barn was one of the few seen with open swallow hole ventilators in the peak.

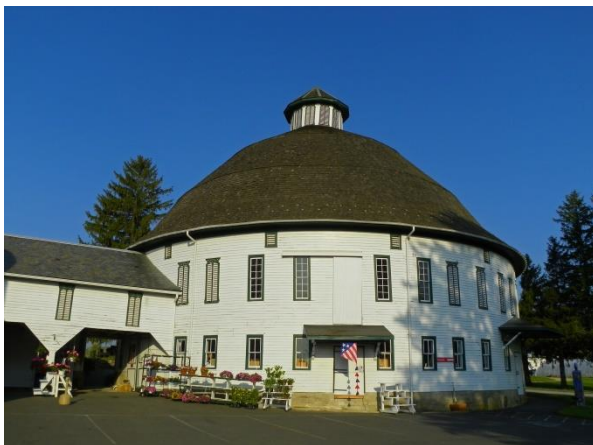
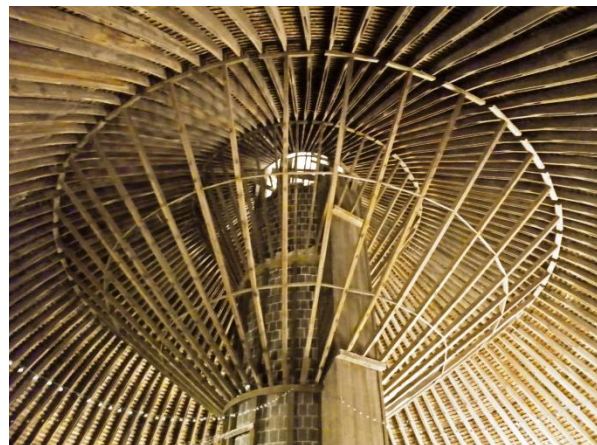
One really can't discuss barns of the Gettysburg area without mentioning the round barn located about eight miles west of Gettysburg. According to their brochure, this 1914 barn has a circumference of 282 feet and a diameter of over 87 feet, with a central silo measuring 60 feet high and 12 feet wide. The barn is "truly an awesome structure to behold!"
