Barn of the Month

John and Mary Swartzlander Barn, Doylestown PA

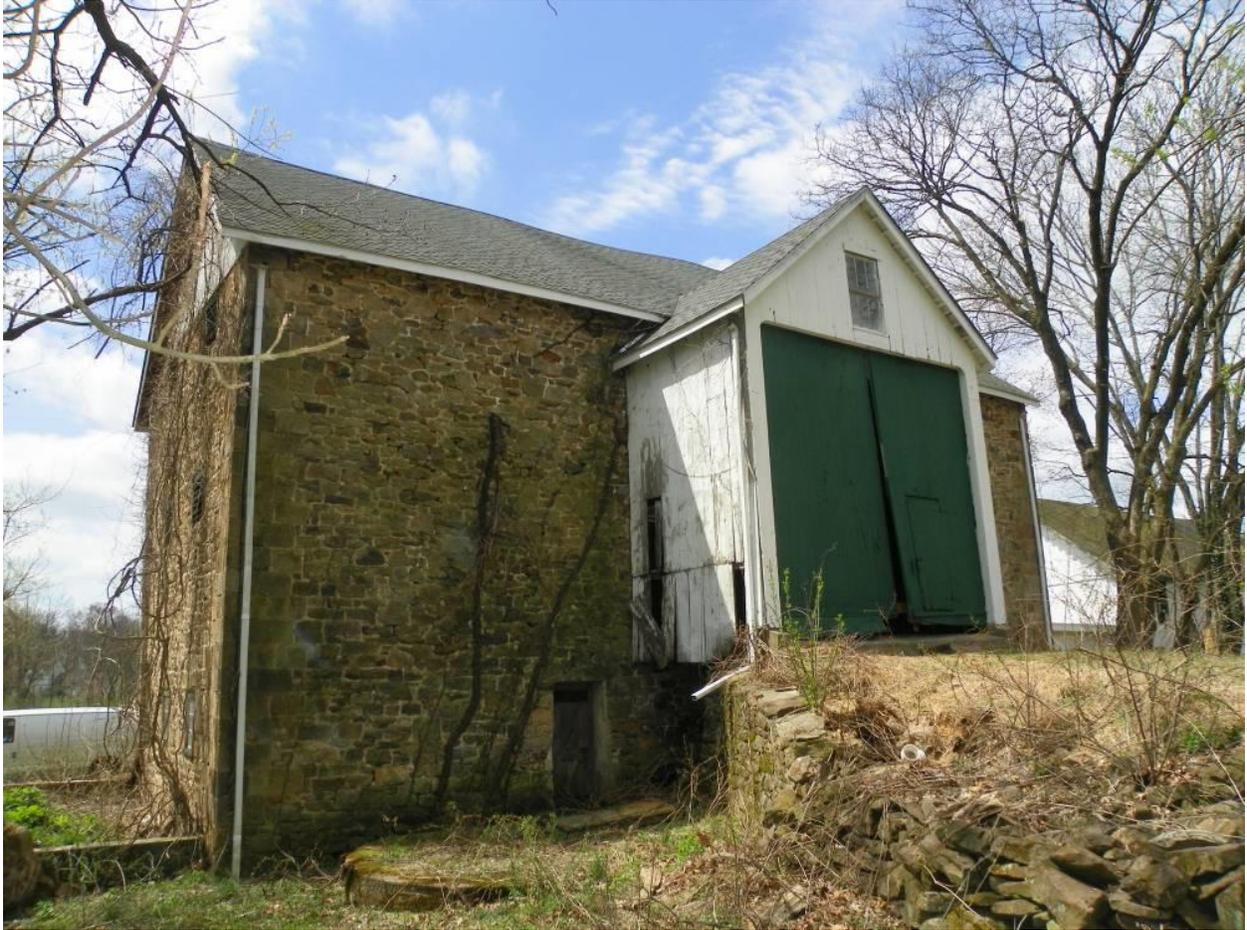
Bank elevation showing wooden bridge house spanning space between barn and bank

The barn is a large stone barn built in the shape of an “L”. The main barn is a predominantly stone structure of a design generally referred to as a bank barn. The barn is a bank barn in that the easterly elevation has wagon doors on the upper level and there is an earthen bank on this elevation providing access to the wagon doors. The earthen bank does not contact the barn wall. Instead there is gap spanned with a wooden bridge. The barn has a gable roof, wood frame, “bridge house” protecting the bridge. The barn has a date stone on the north gable that reads “M J & S 1814”. The upper level of the barn is divided into three major units called bays. There is a central bay used for threshing grain and equipment storage flanked by large mows where loose hay was stacked for storage until it was threshed. Functionally, this barn is referred to as a three-bay bank barn.

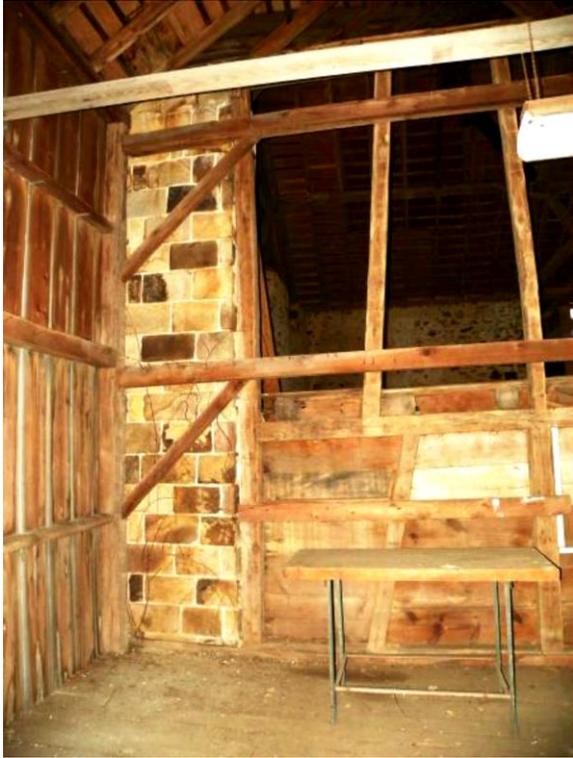
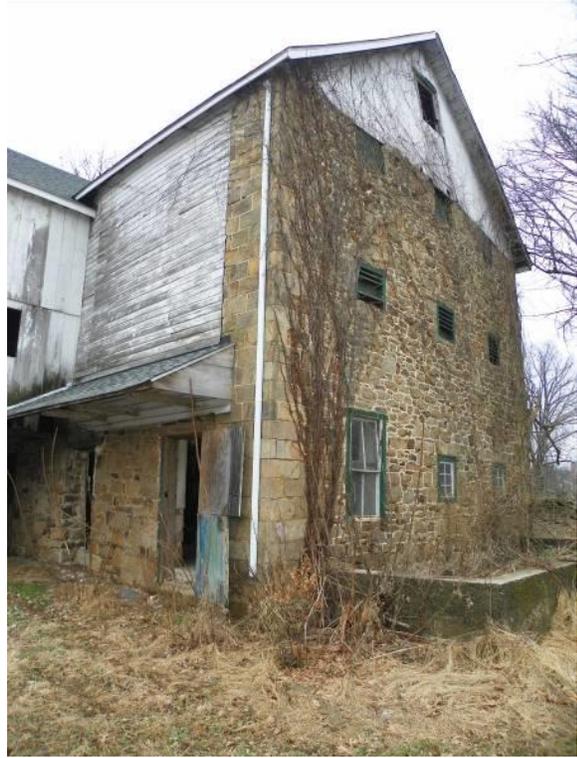
West elevation showing cut stone quoins and open area corresponding to wooden wall visible from exposed section of wall (left). West elevation showing stone wall at stable level below wooden wall (right).

The westerly, barnyard, elevation has a frame wall above the stone stable level. The stable level has a number of doors opening into the barnyard. Generally, these frame walls are above a recessed area created by the stable wall being recessed back several feet from the front wall of the barn providing a protected area. This forms a protected work area referred to as a “closed forebay”. This pattern is distinct from the early Pennsylvania German barns, where the forebay projected out beyond the front wall of main barn. Unlike most barns of this variety, the stone wall on this elevation is flush with the exterior wall and not recessed. It is possible that the entire barn was stone and when the wing was added the remaining stone wall was taken down to the stable level to maintain stability or that it was constructed as a variant of the closed forebay form.

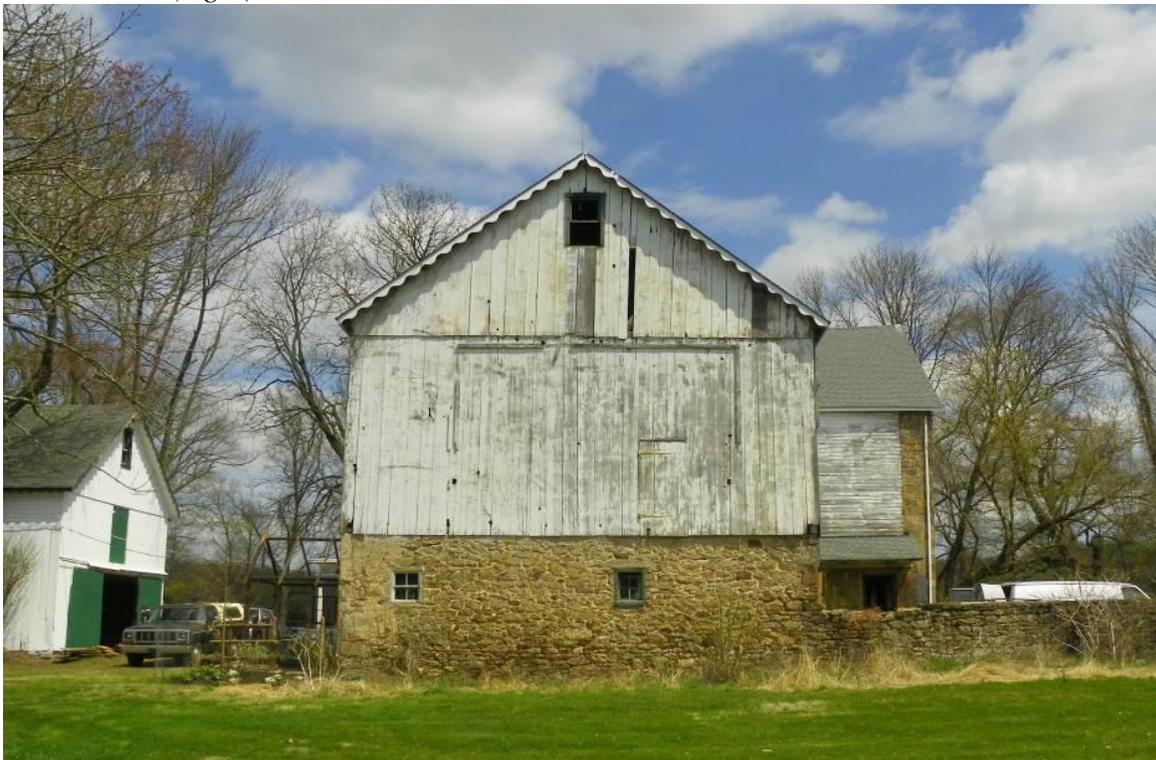
Straw shed wing of barn

Attached to the westerly barnyard elevation is a full height “L” wing used functionally as a “straw shed”. Most straw sheds were later additions to traditional three-bay barns. Generally, and in this instance, the straw shed is an extension that is perpendicular to the main barn. Straw barns became popular after the advent of mechanical threshing machines. A portable steam thresher sat on the upper level barn floor and blew the straw to the rear of the barn. Later barns were built with straw sheds incorporated in the planning and this type of barn is often called a three end or three gable barn. Like many straw sheds, the upper level of this one was used to store straw and the bottom level was used to house animals and store equipment.

The ground level of the straw shed is stone and the upper level is wood frame construction. The roof extends out beyond the gable end of the wing and there is scalloped bargeboard detailing. There is a gap between the stone portion of the wing and the main barn which allows wagons to drive into the barnyard.

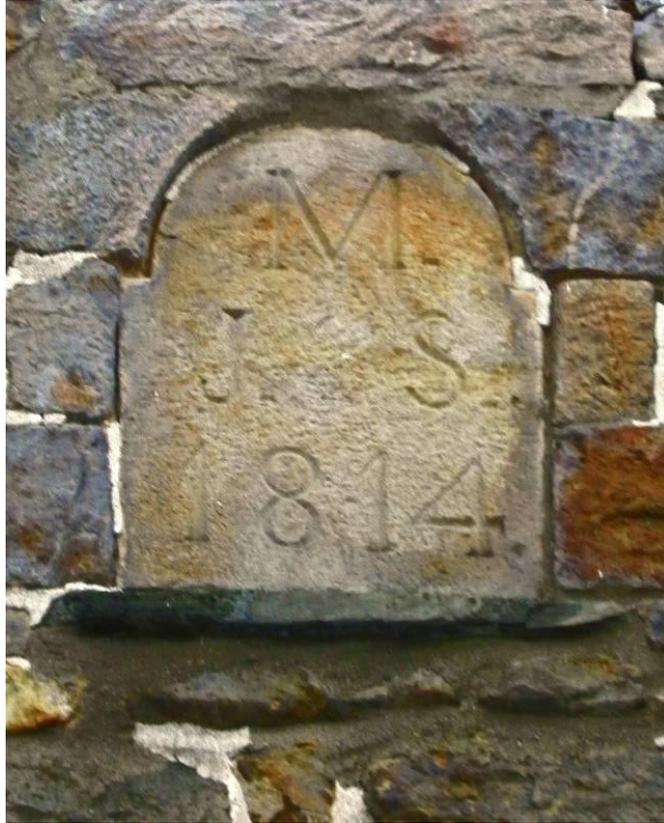
If the date stones on the house and barn are references to John and Mary Swartzlander then they are different than any other similar stones where the upper initial reflects the surname and the lower initials that of the given names of the husband and wife. To be consistent with most date stones, the “S” should be at the top and the “J” for John and “M” for Mary below it.
